Nevada
Environmental
Restoration
Project

DOE/NV--1133

Post-Closure Inspection Report for
the Tonopah Test Range, Nevada

For Calendar Year 2005

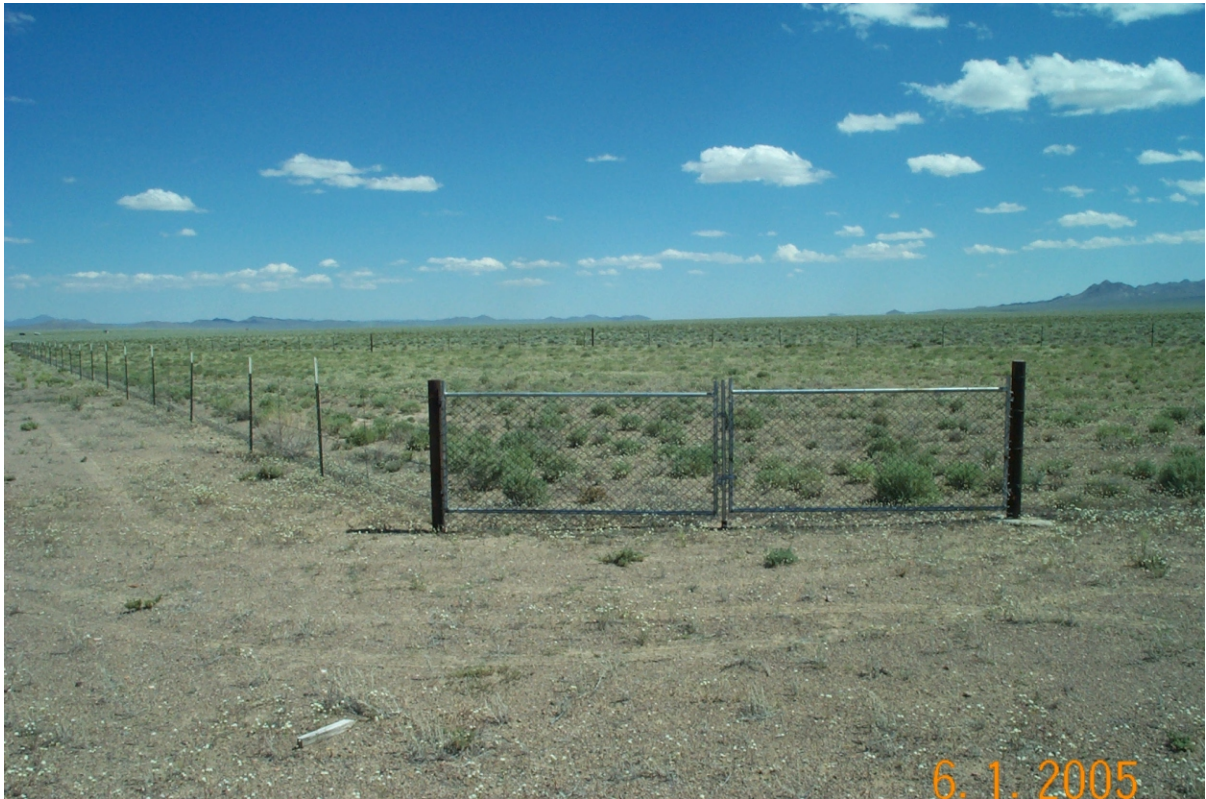
Photograph 1: CAU 400 Bomblet Pit, looking south, 06/01/05

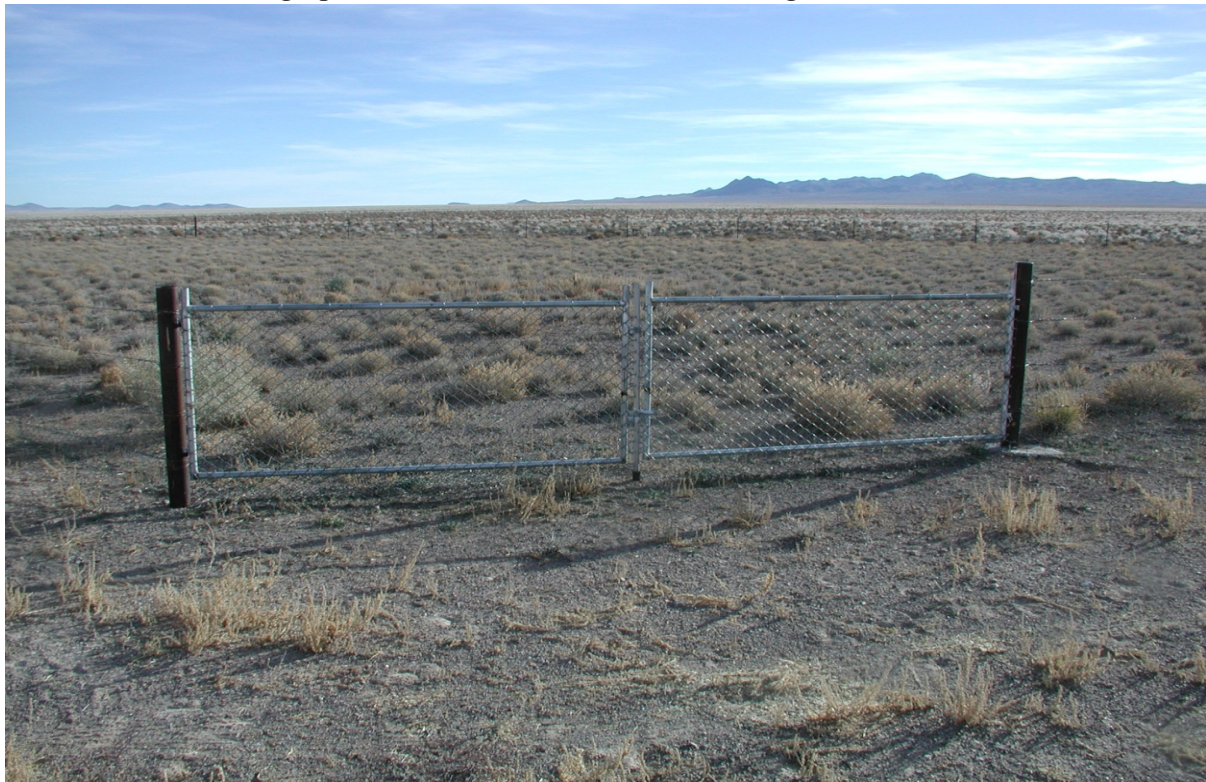
Photograph 2: CAU 400 Bomblet Pit, looking south, 11/15/05

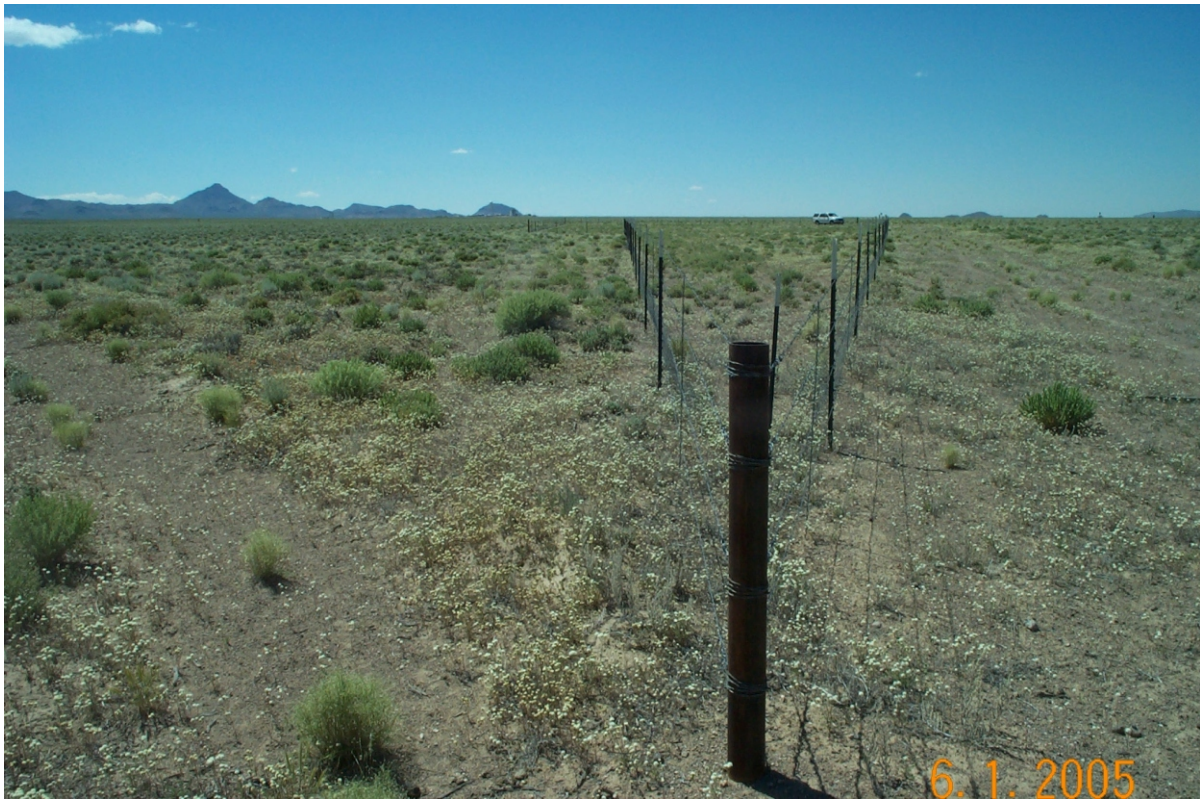
Photograph 3: CAU 400 Bomblet Pit, looking west, 06/01/05

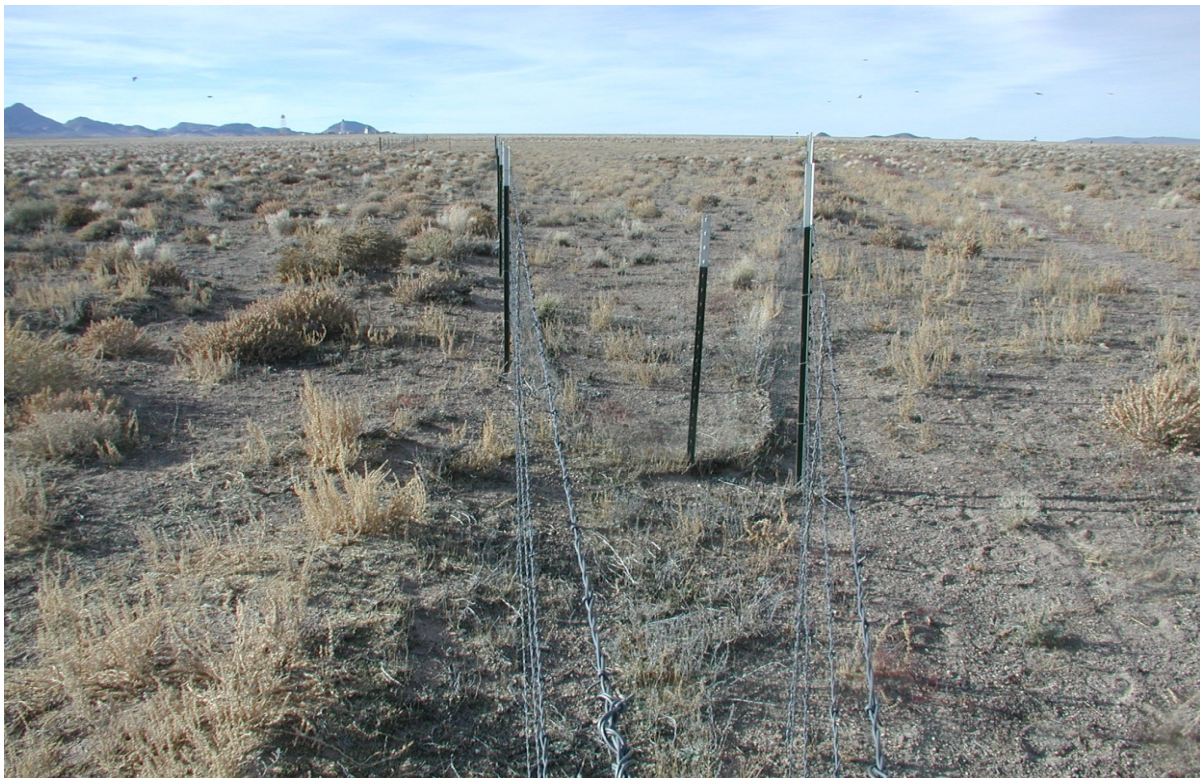
Photograph 4: CAU 400 Bomblet Pit, looking west, 11/15/05

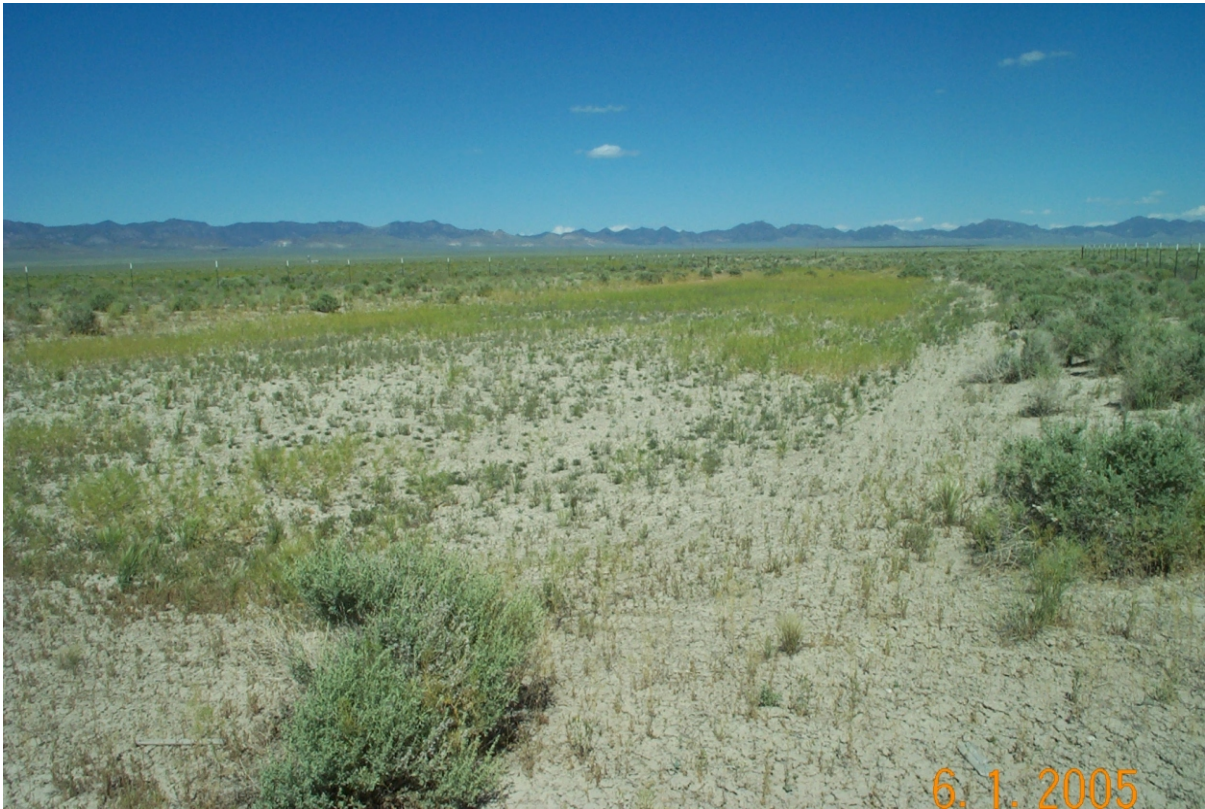
Photograph 5: CAU 400 Five Points Landfill, looking east, 06/01/05

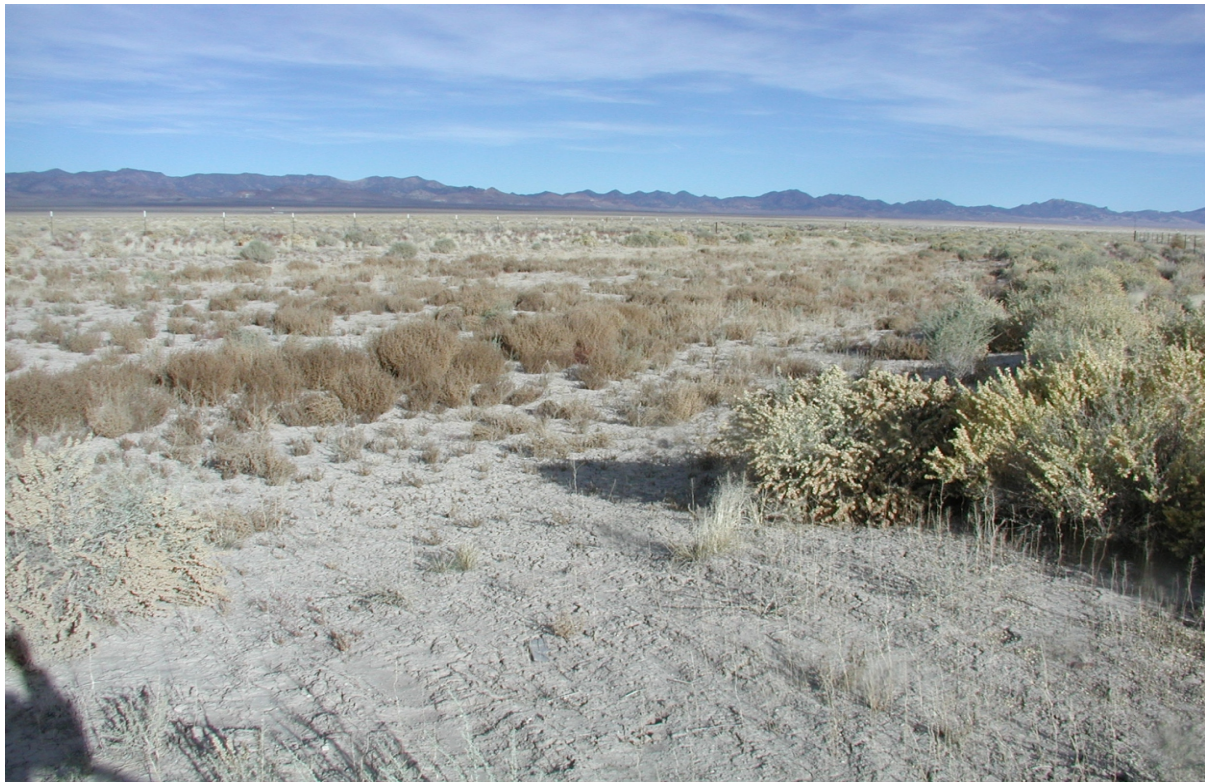
Photograph 6: CAU 400 Five Points Landfill, looking east, 11/15/05

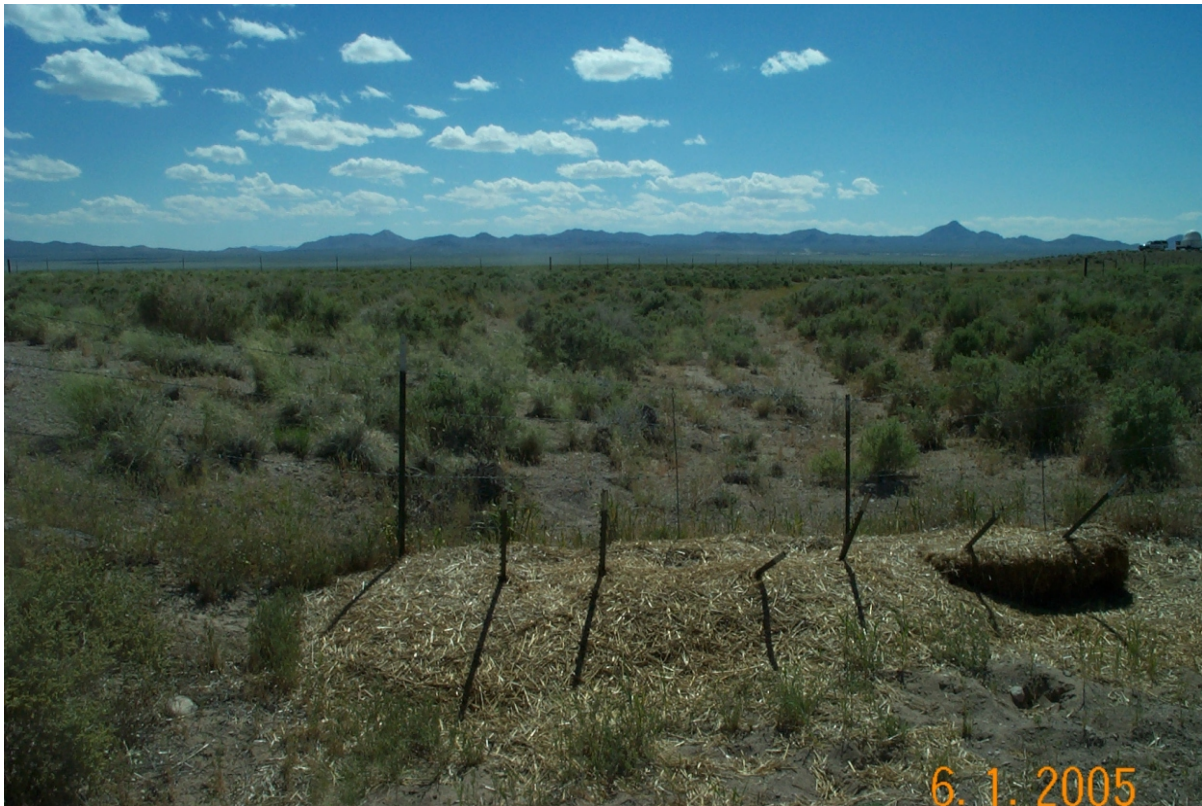
Photograph 7: CAU 400 Five Points Landfill, looking east, 06/01/05

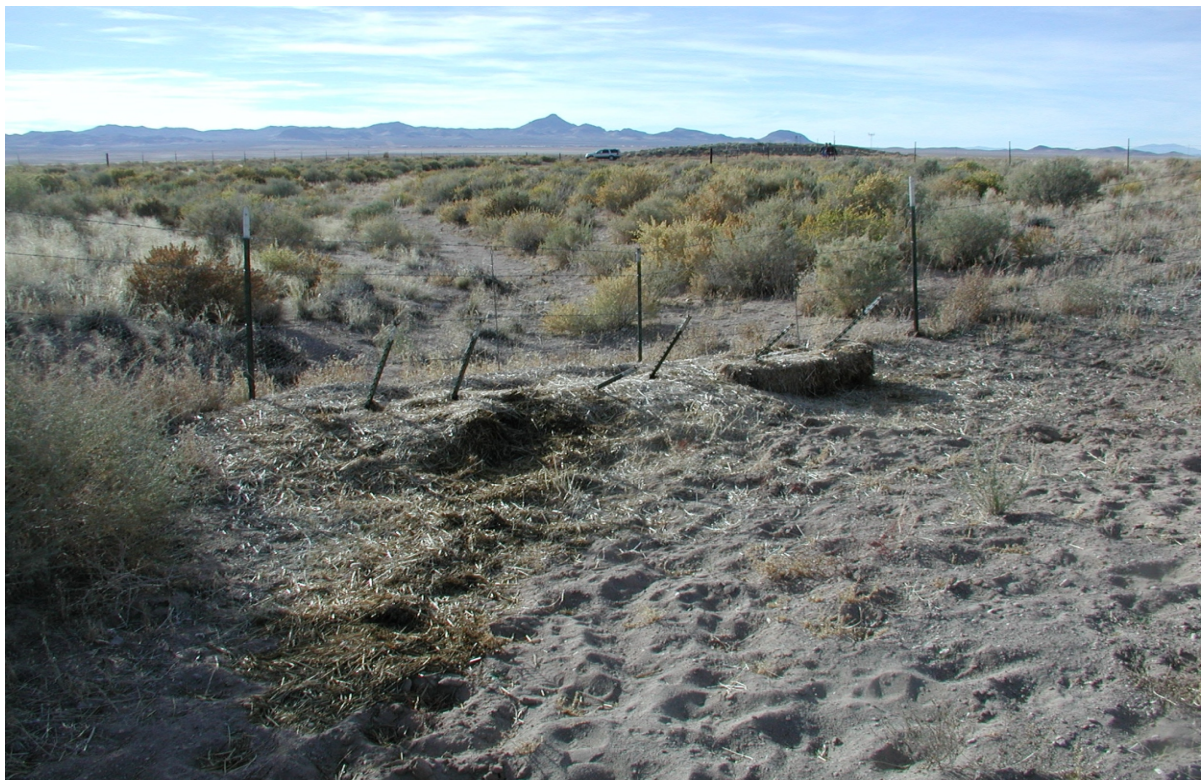
Photograph 8: CAU 400 Five Points Landfill, looking east, 11/15/05

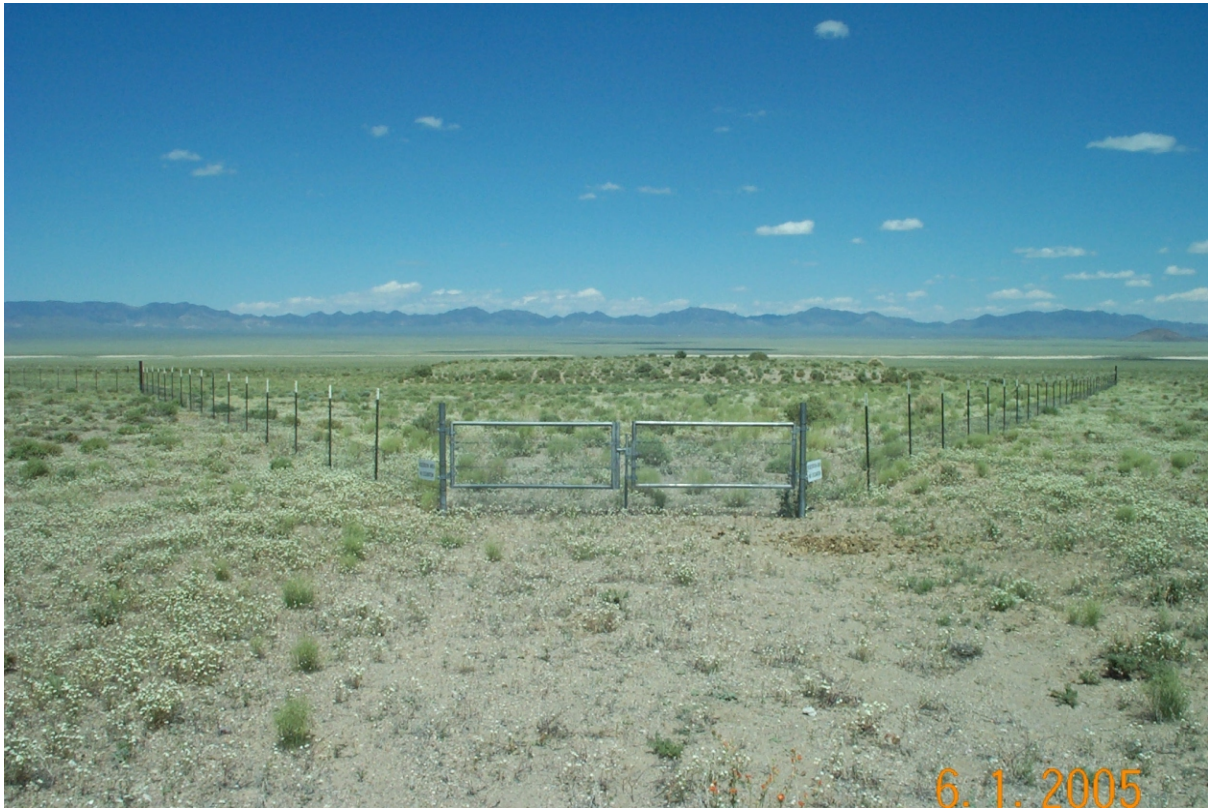
Photograph 9: CAU 404, looking east, 06/01/05

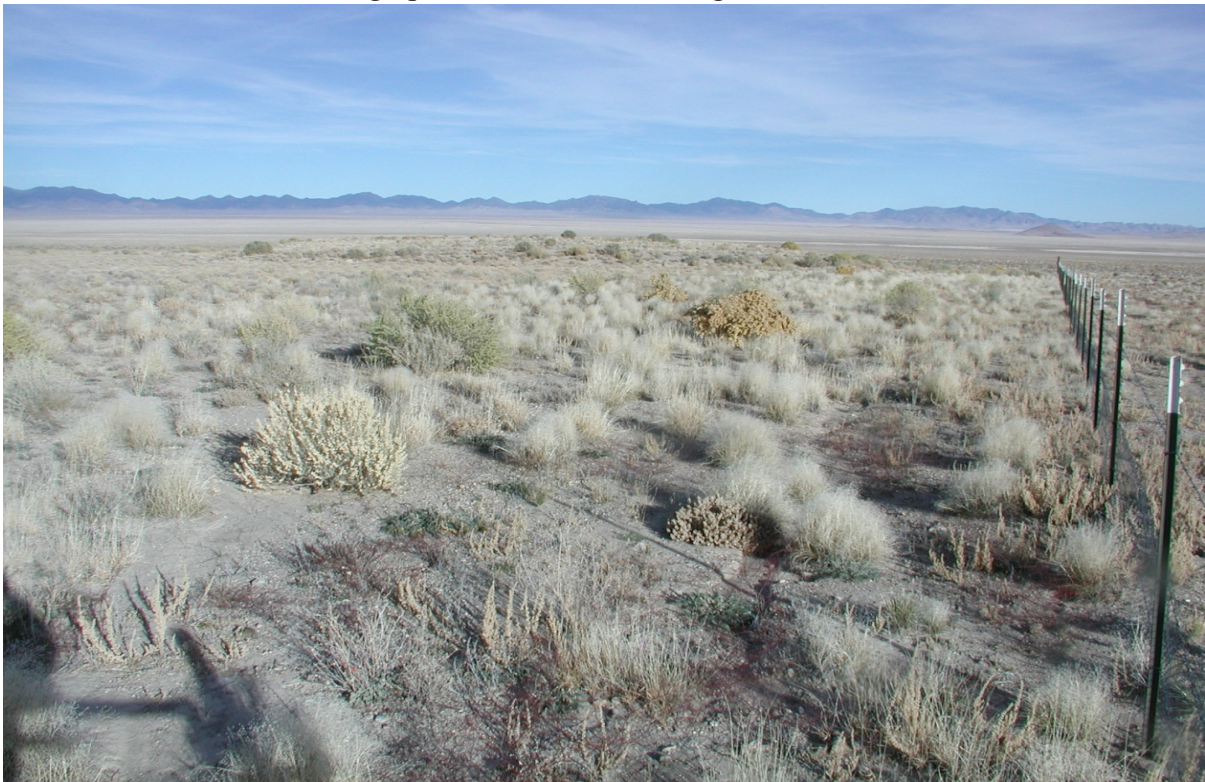
Photograph 10: CAU 404, looking east, 11/15/05

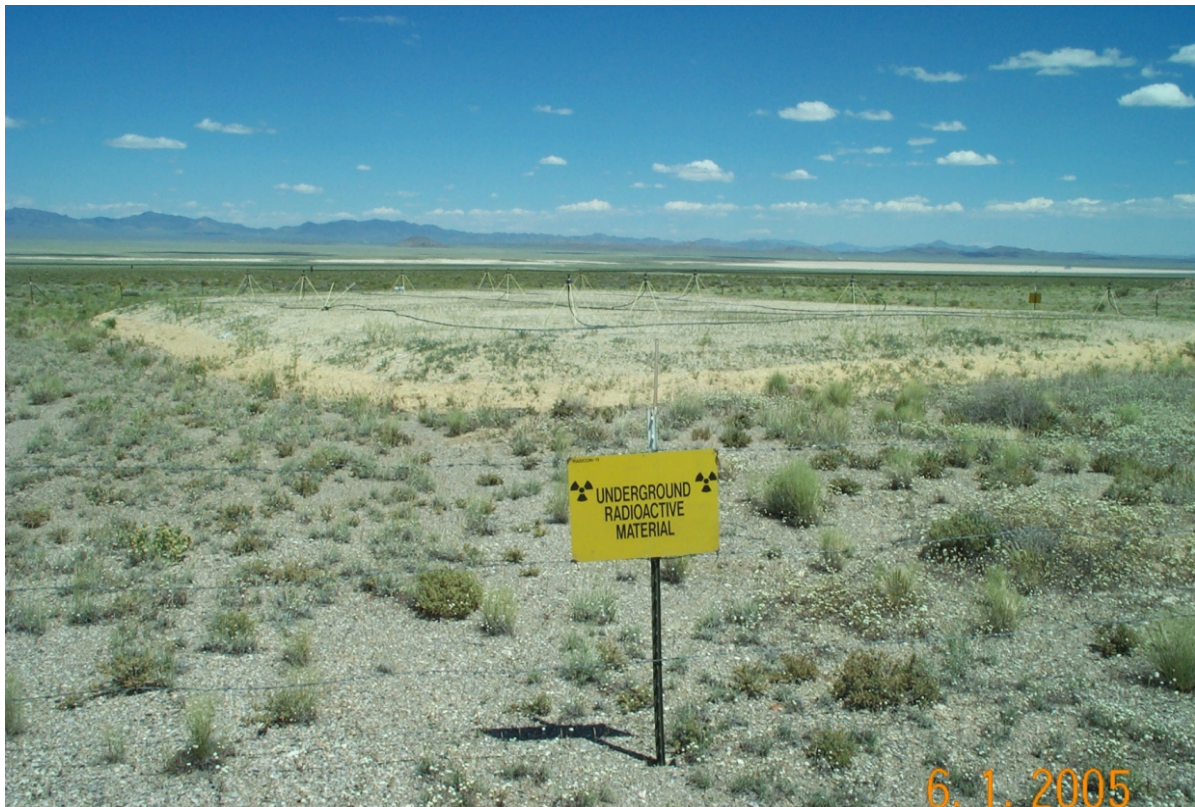
Photograph 11: CAU 407, looking east, 06/01/05

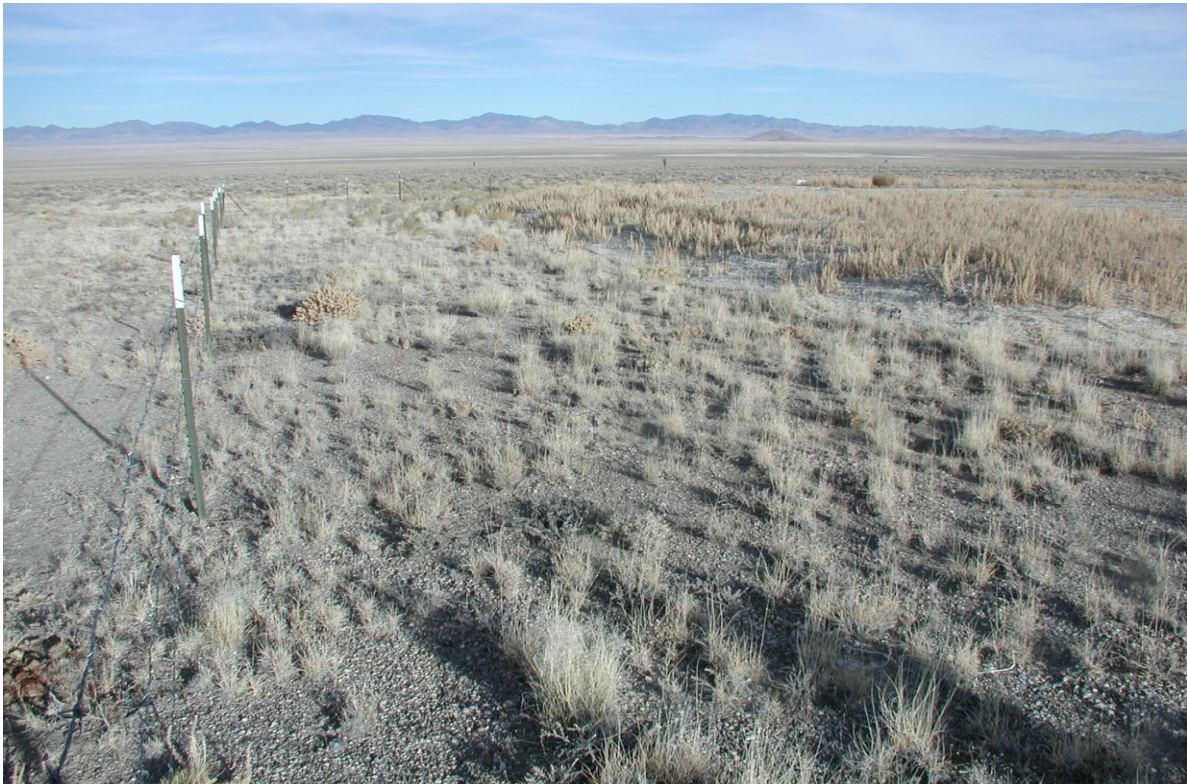
Photograph 12: CAU 407, looking east, 11/15/05

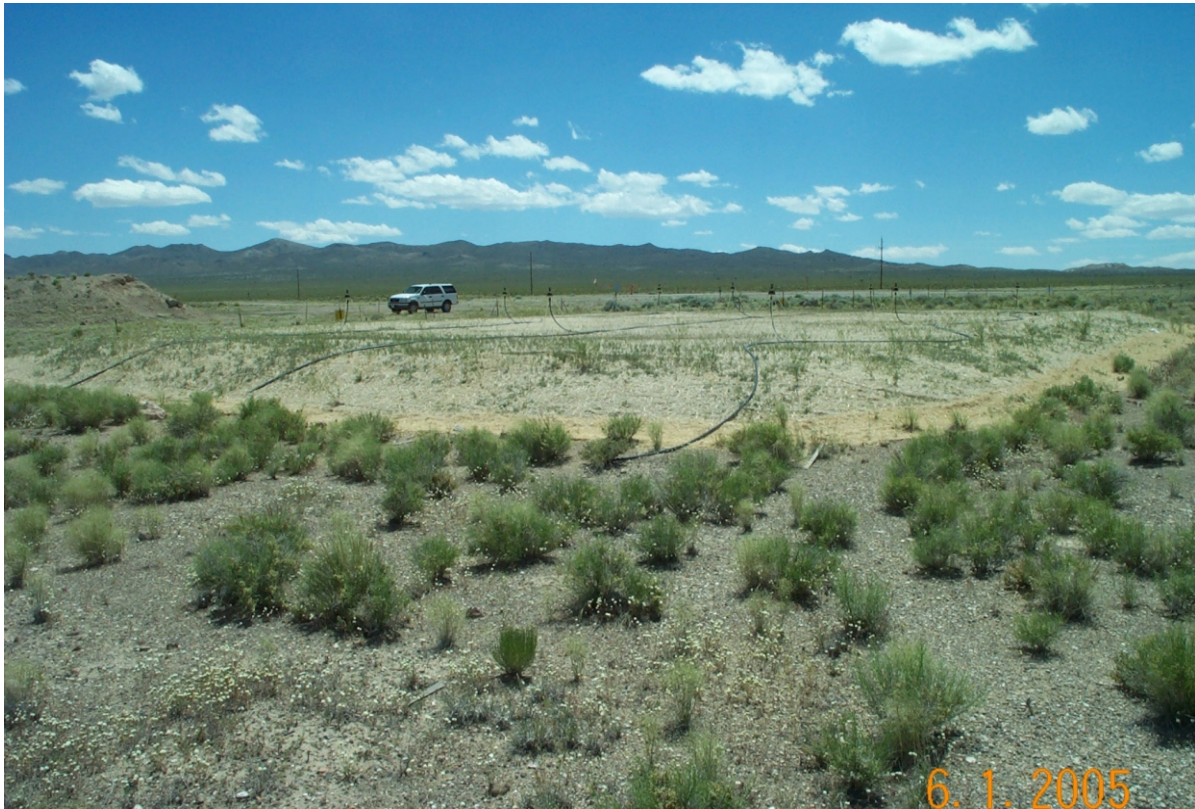
Photograph 13: CAU 407, looking southwest, 06/01/05

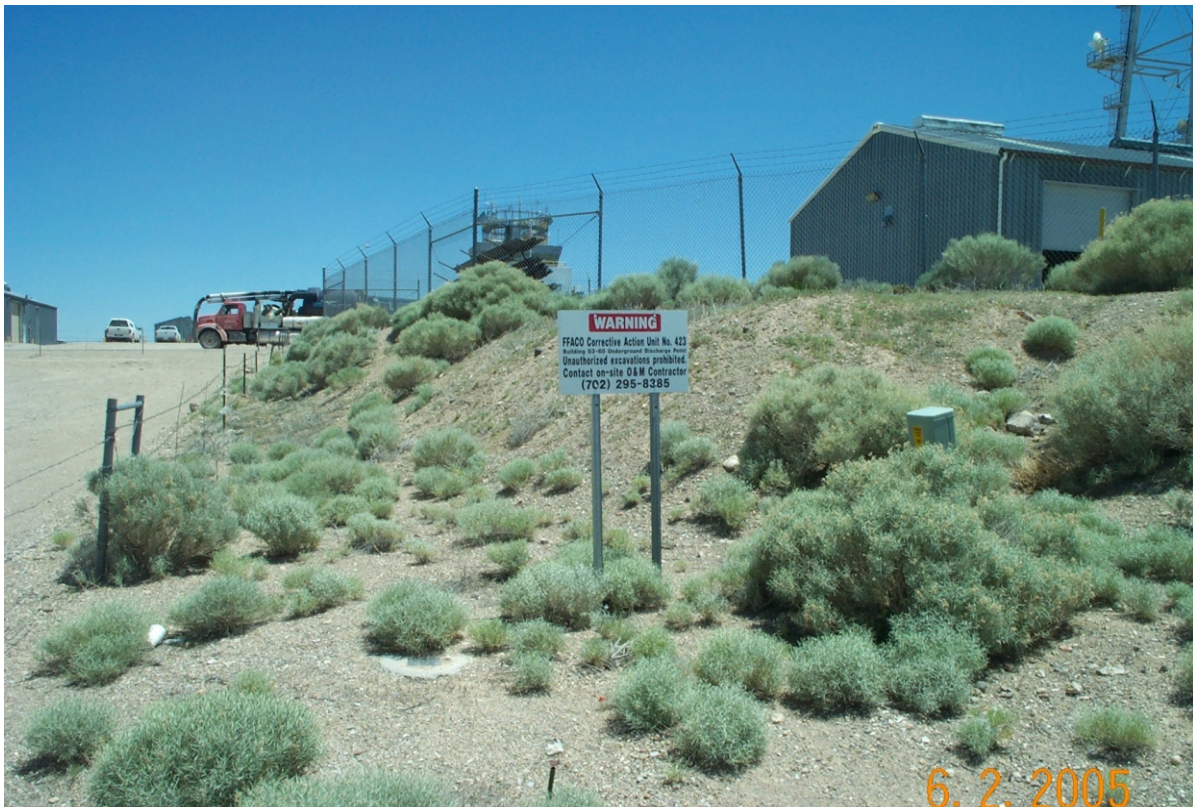
Photograph 15: CAU 423, looking east, 06/02/05

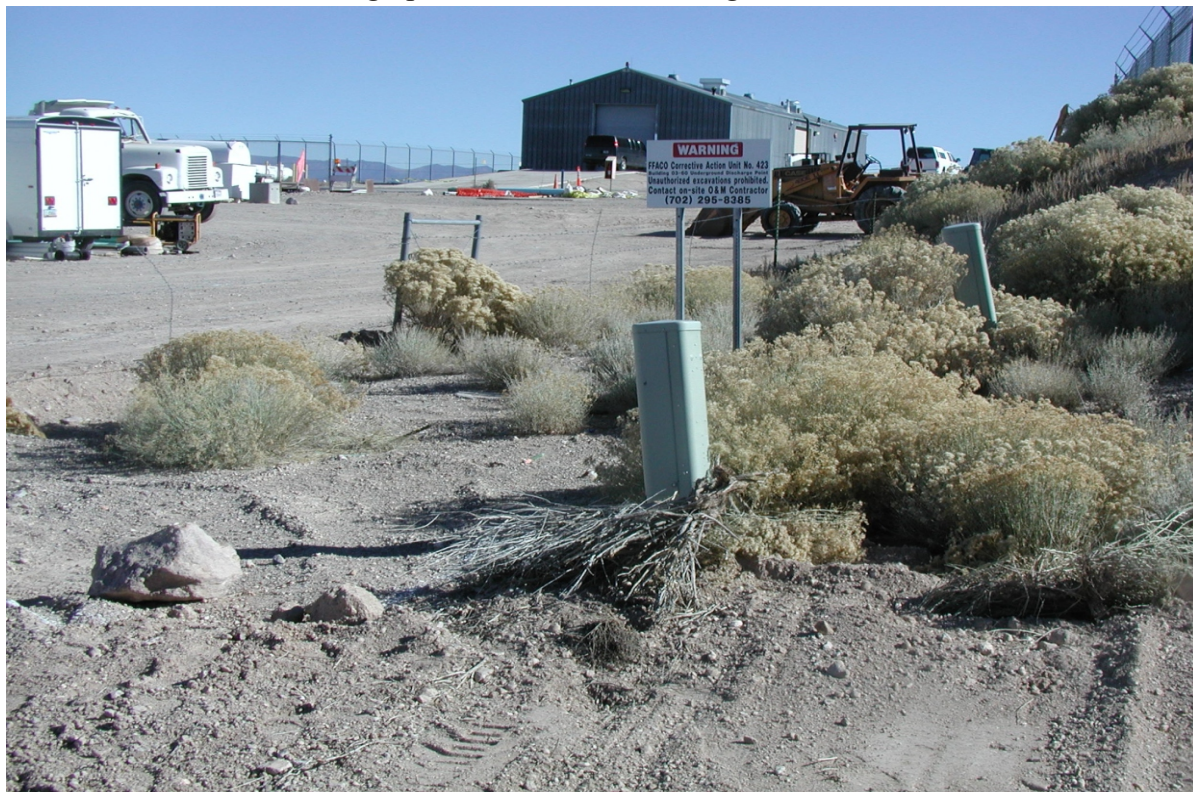
Photograph 16: CAU 423, looking east, 11/16/05

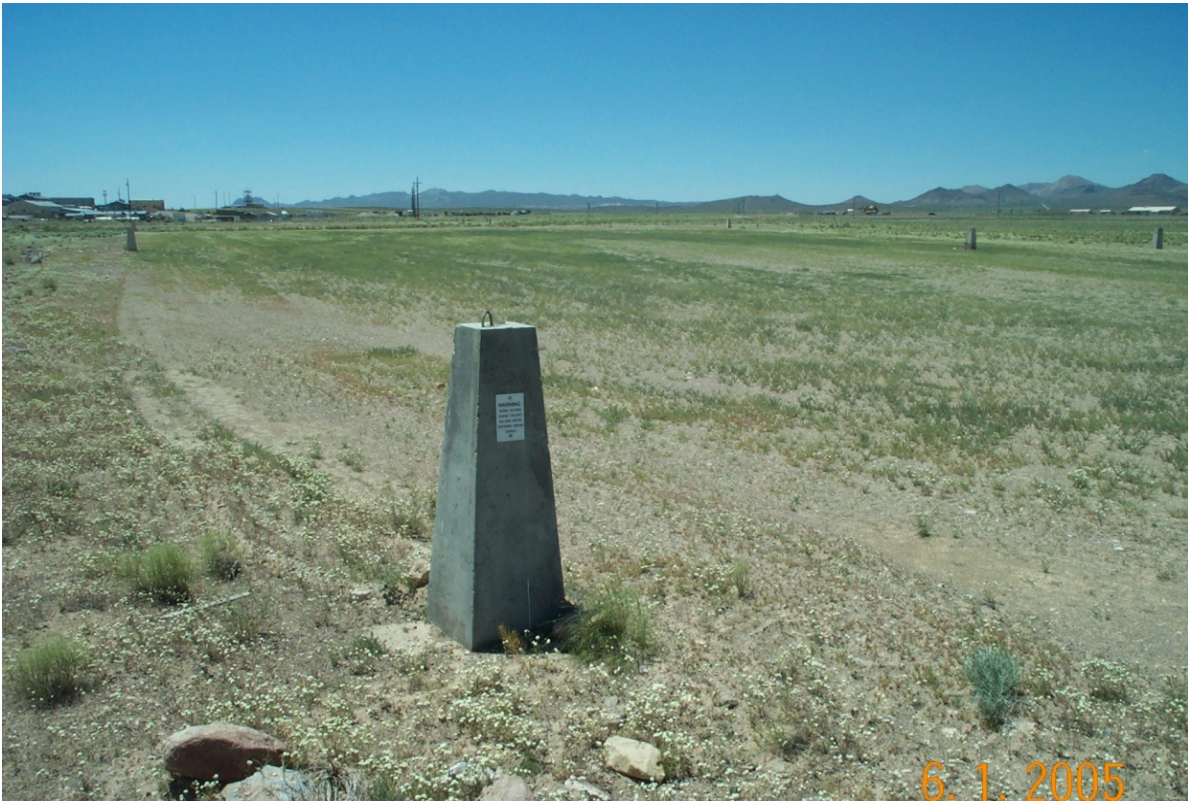
Photograph 17: CAU 424, Landfill Cell A3-1, looking south, 06/01/05

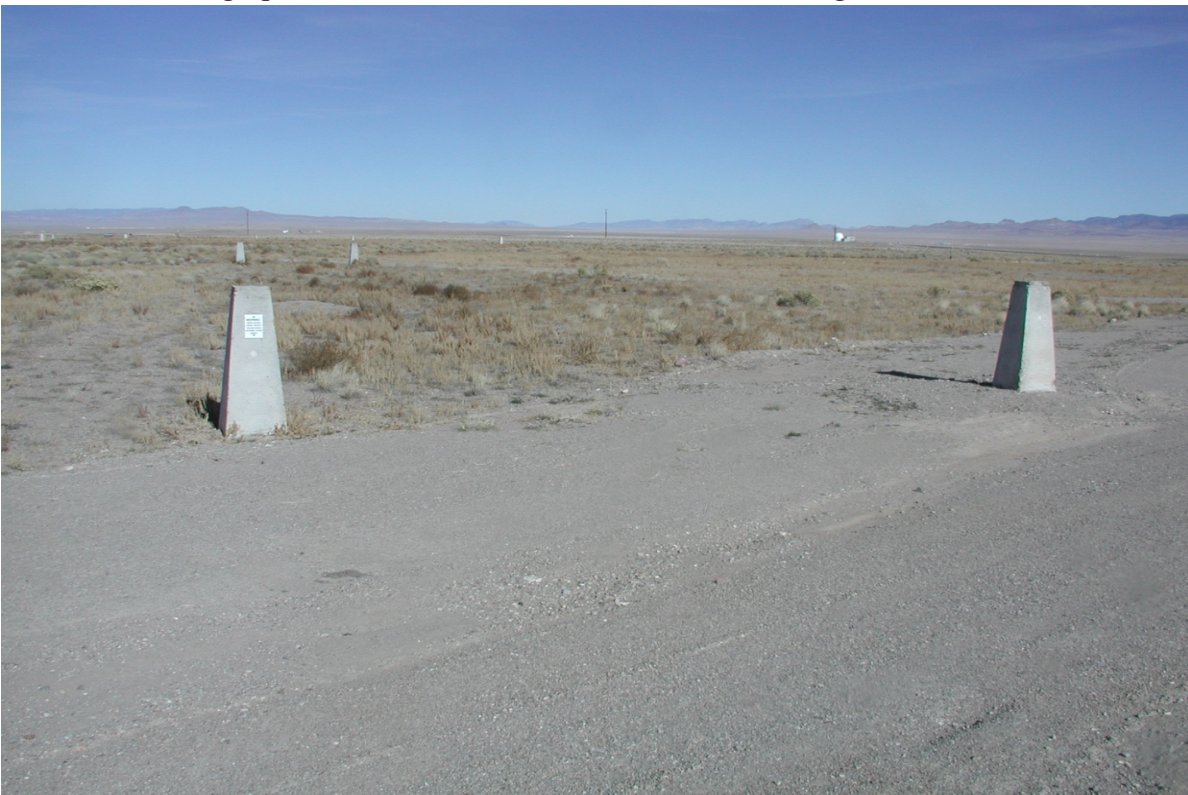
Photograph 18: CAU 424, Landfill Cell A3-1, looking north, 11/16/05

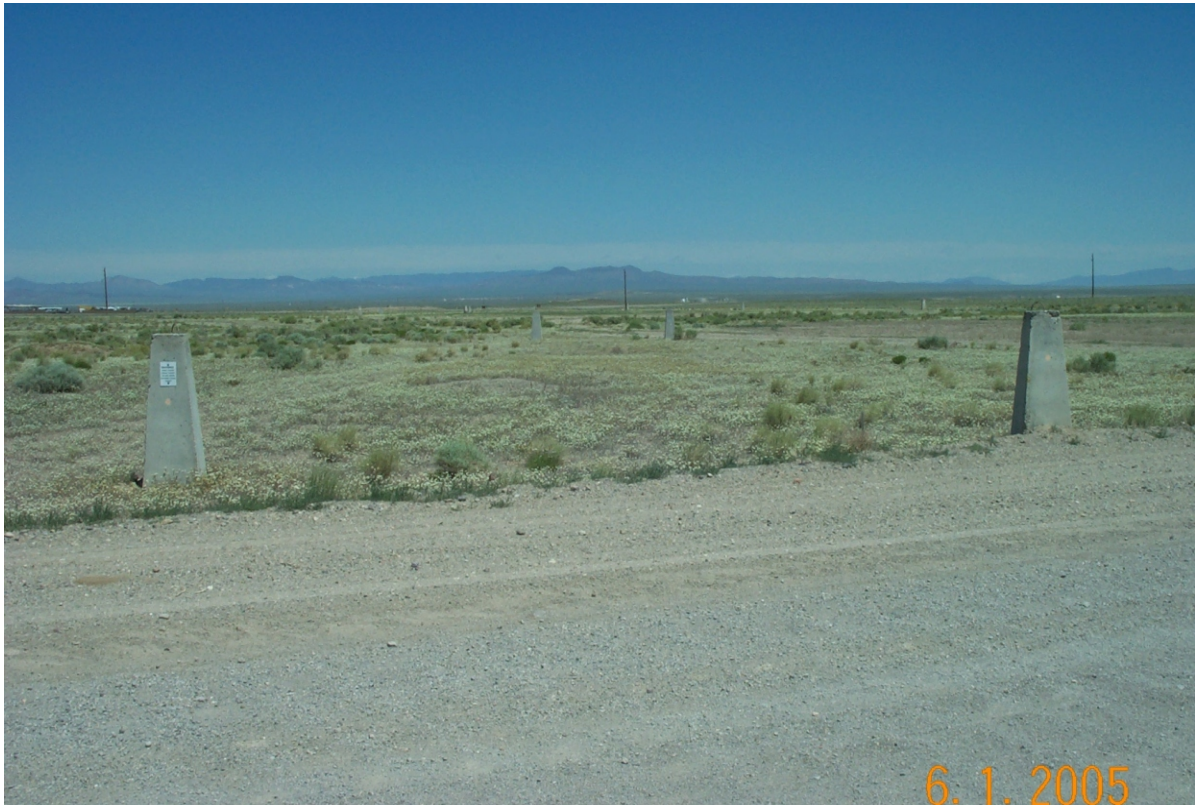
Photograph 19: CAU 424, Landfill Cell A3-2, looking north, 06/01/05

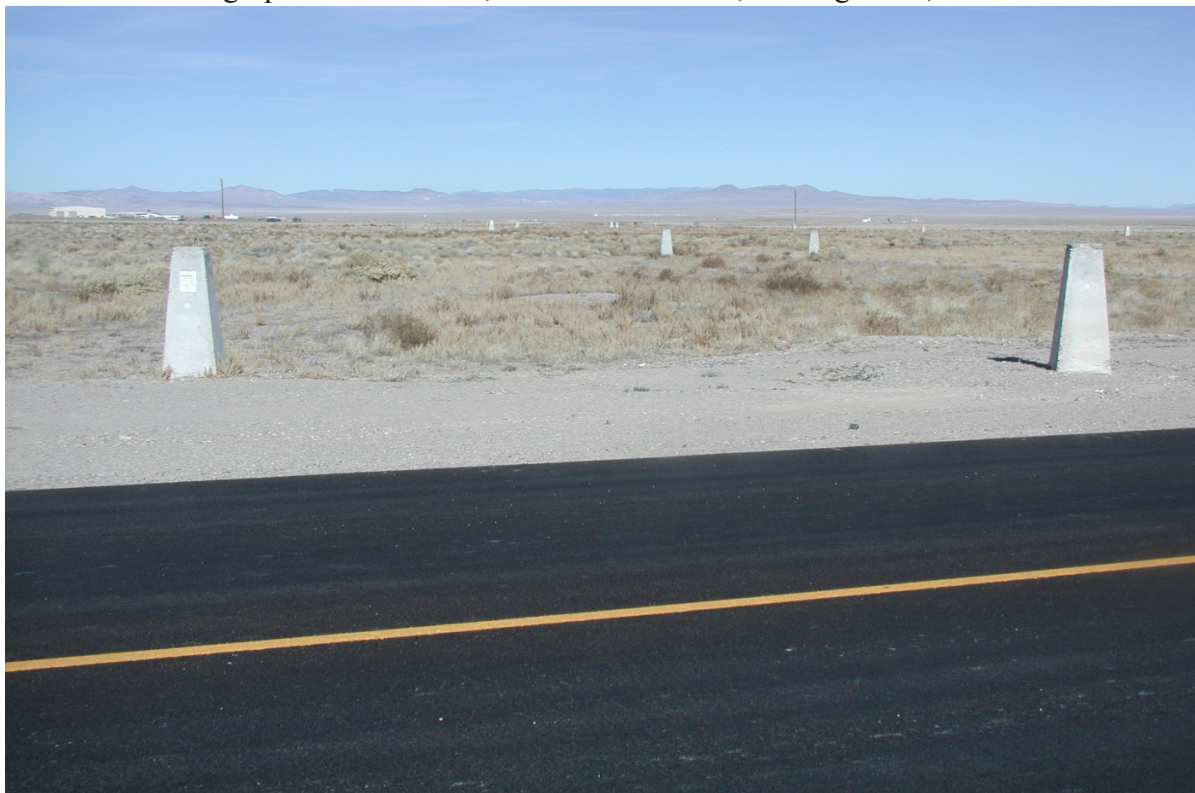
Photograph 20: CAU 424, Landfill Cell A3-2, looking north, 11/16/05

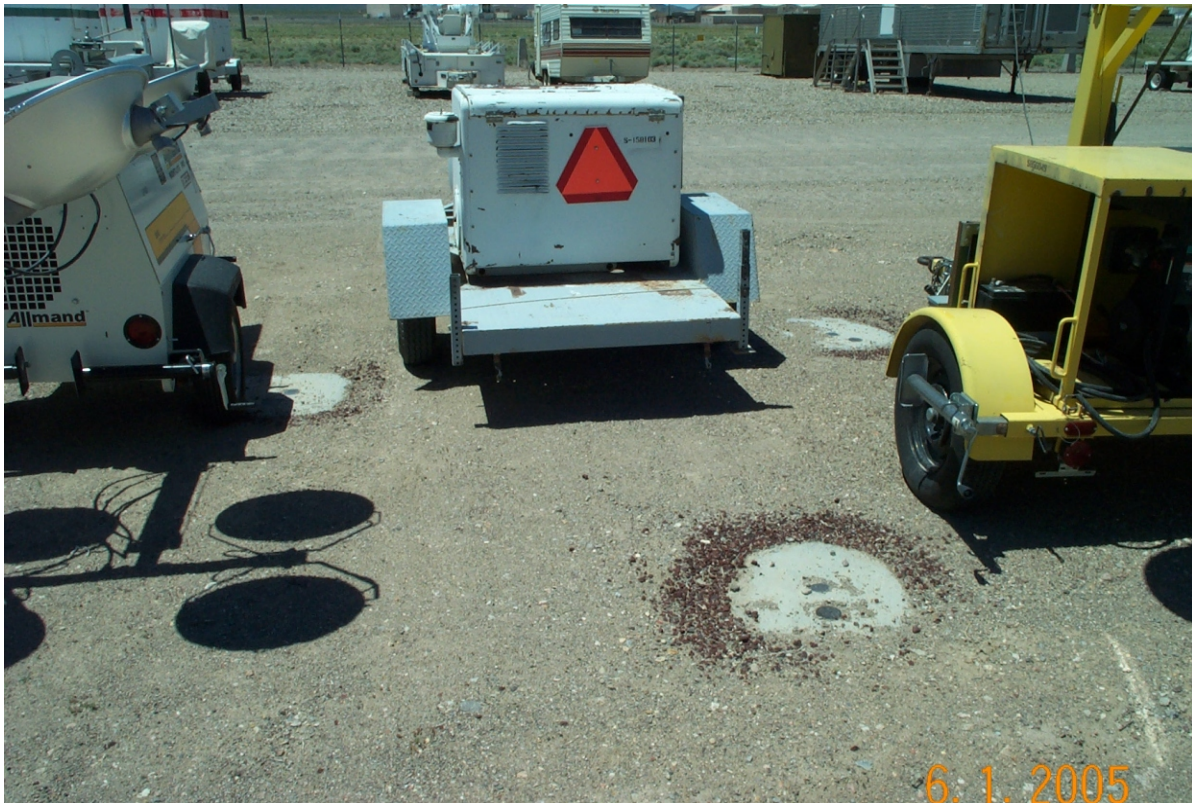
Photograph 21: CAU 424, Landfill Cell A3-3, looking west, 06/01/05

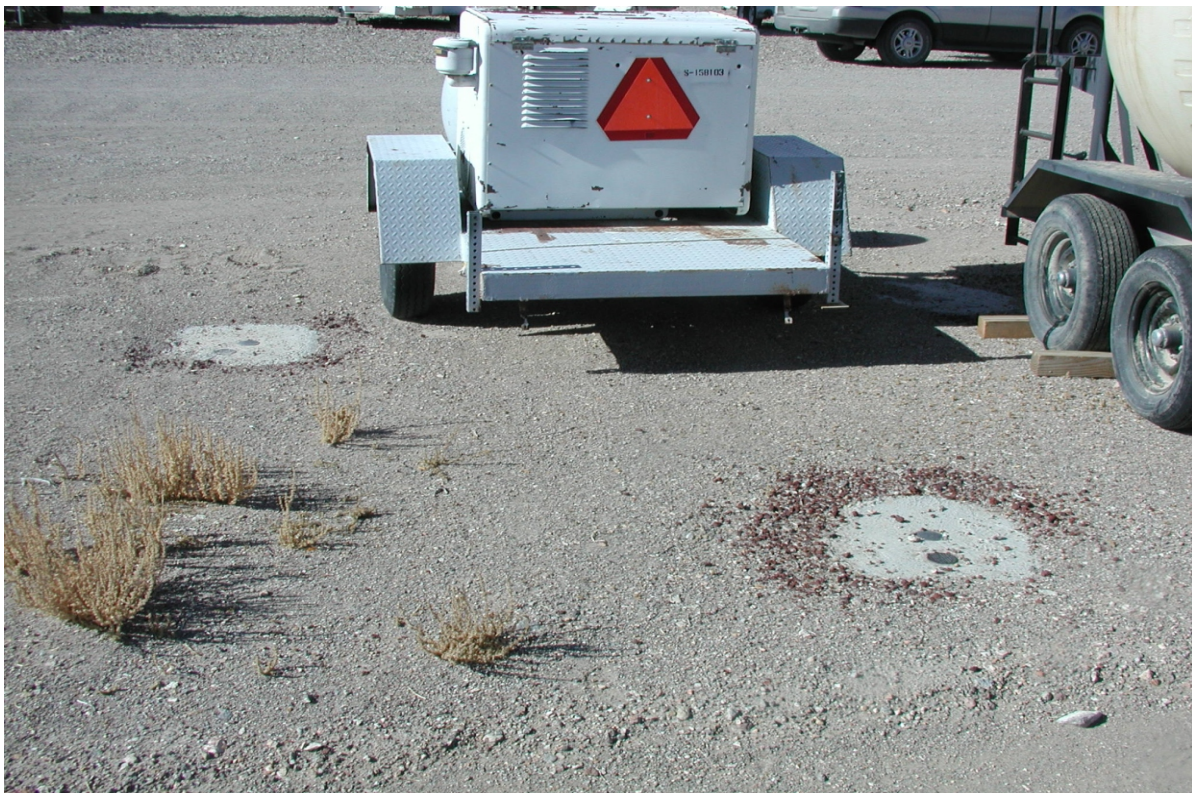
Photograph 22: CAU 424, Landfill Cell A3-3, looking west, 11/16/05

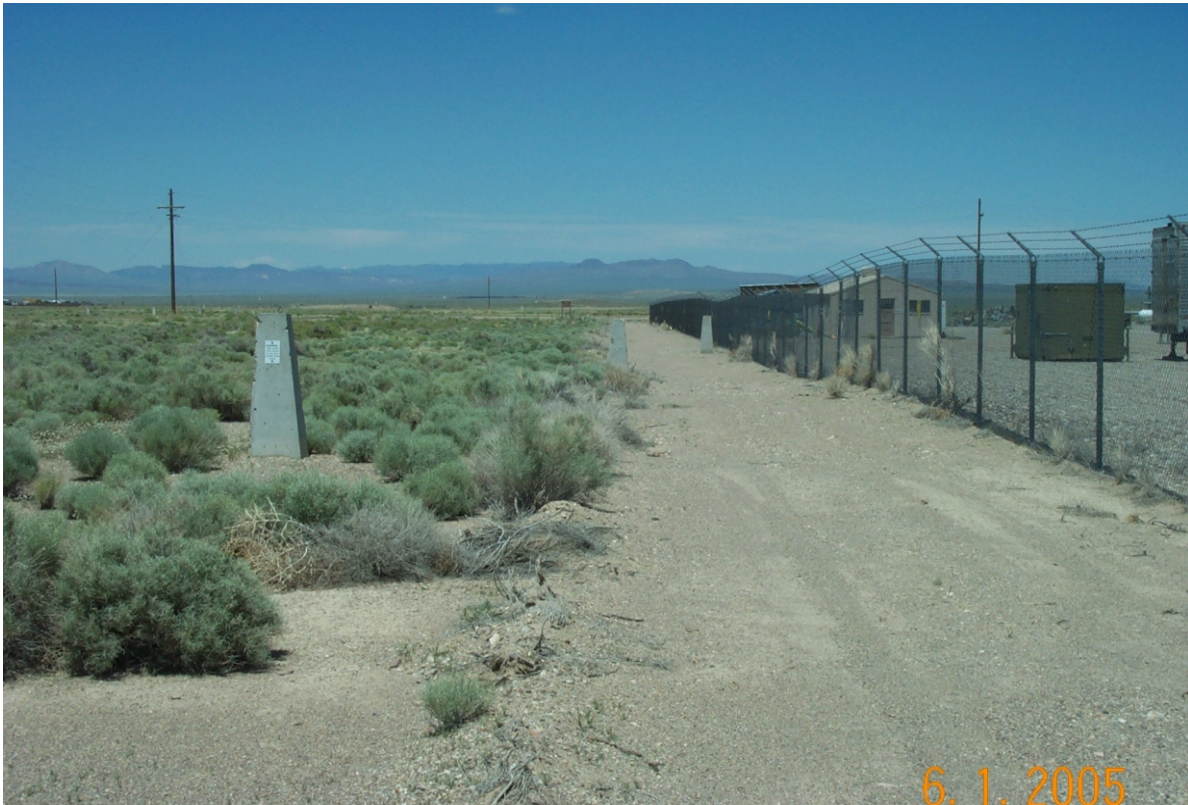
Photograph 23: CAU 424, Landfill Cell A3-3, looking north, 06/01/05

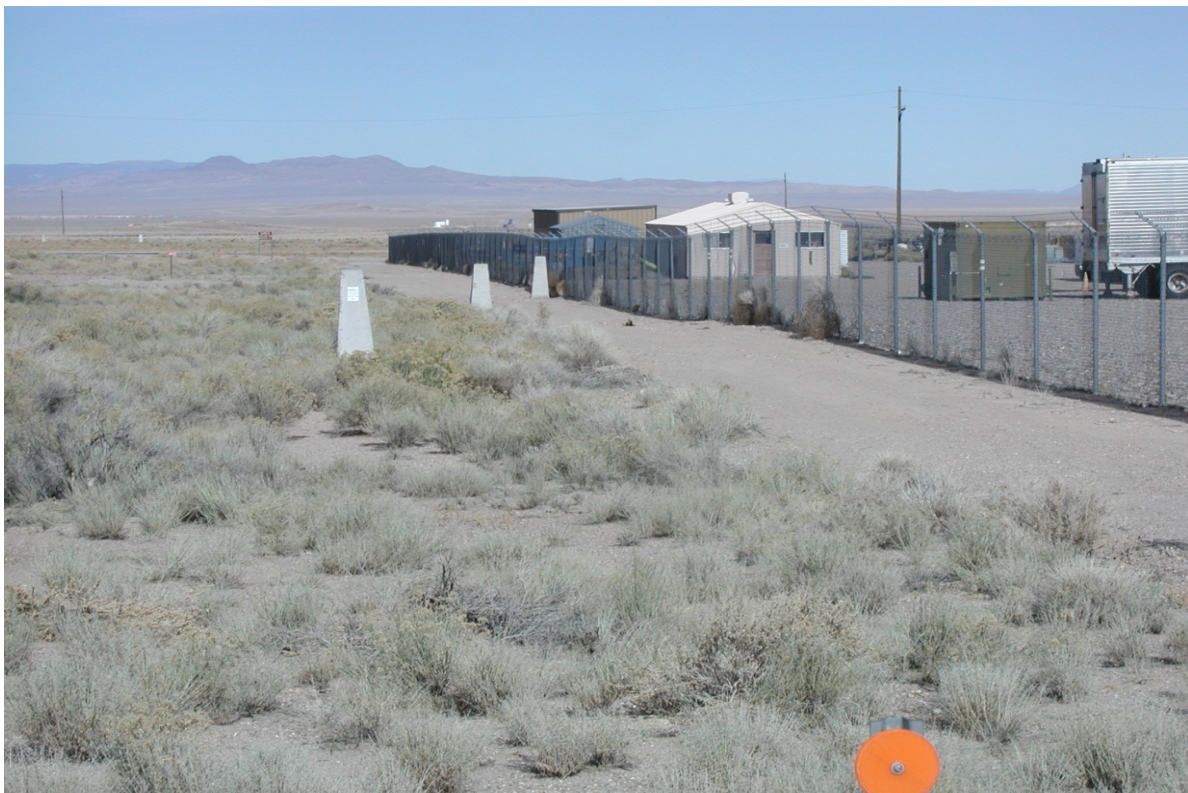
Photograph 24: CAU 424, Landfill Cell A3-3, looking north, 11/16/05

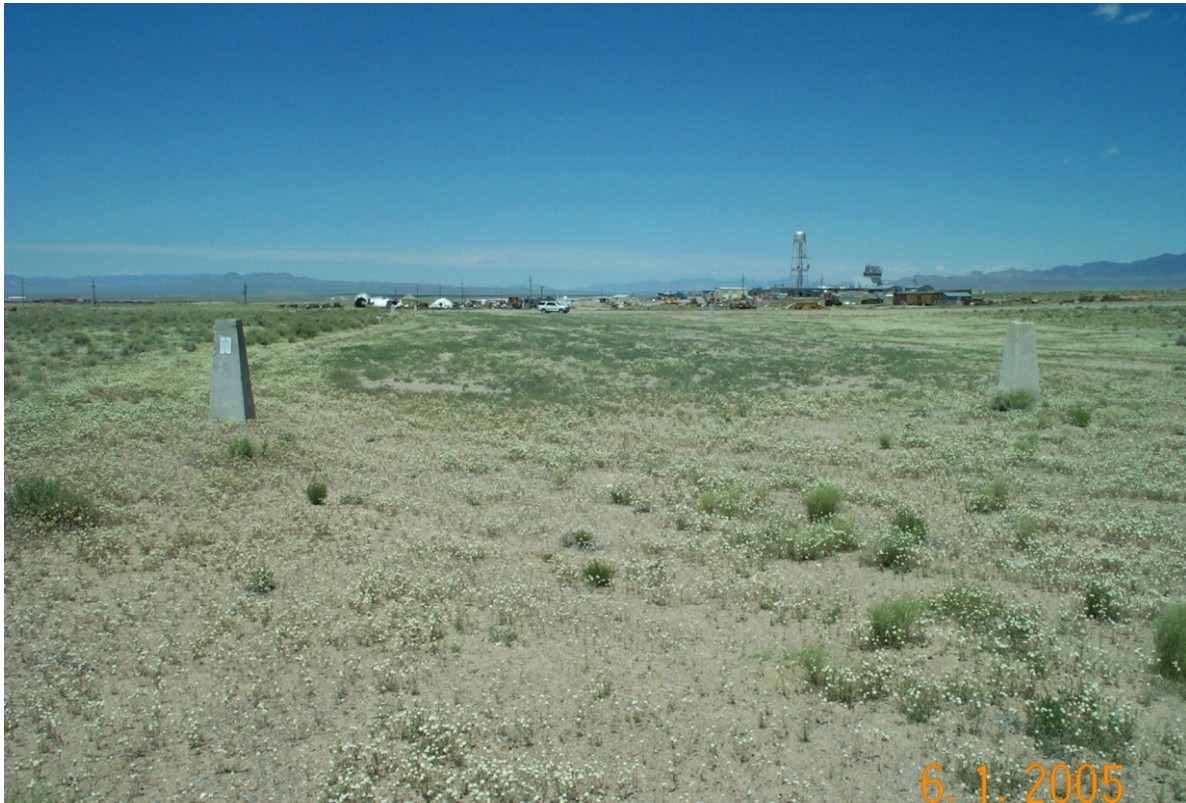
Photograph 25: CAU 424, Landfill Cell A3-4, looking north, 06/01/05
